# Quick Look Report

COUNTER IMPROVISED EXPLOSIVE DEVICES  
CENTRE OF EXCELLENCE

## St Petersburg Train Bombing

**Event Date: 03 April 2017**

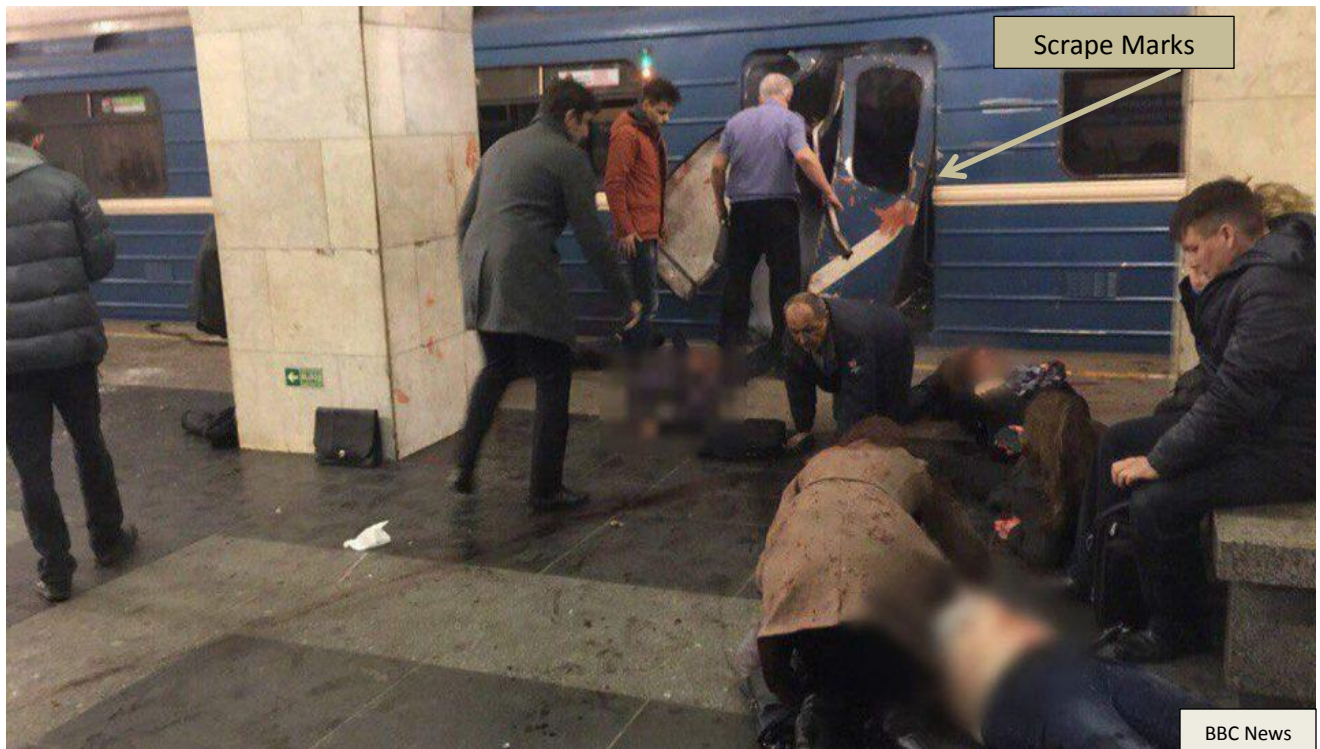
1. Below are images of the metro car's exterior. The first set of doors are nearly torn off but this appears to have added damage, probably from

**the movement of the train against the tunnel, indicated by the exterior scrapes and the direction of the damage being relative to the train's motion. A second set of doors can also be seen bowed outward but not to the extent of the first set. The window panel in between the two doors is missing while the window panels on either side are still intact. This indicates the blast center being somewhere between those two doors more than likely closer to the first set.**

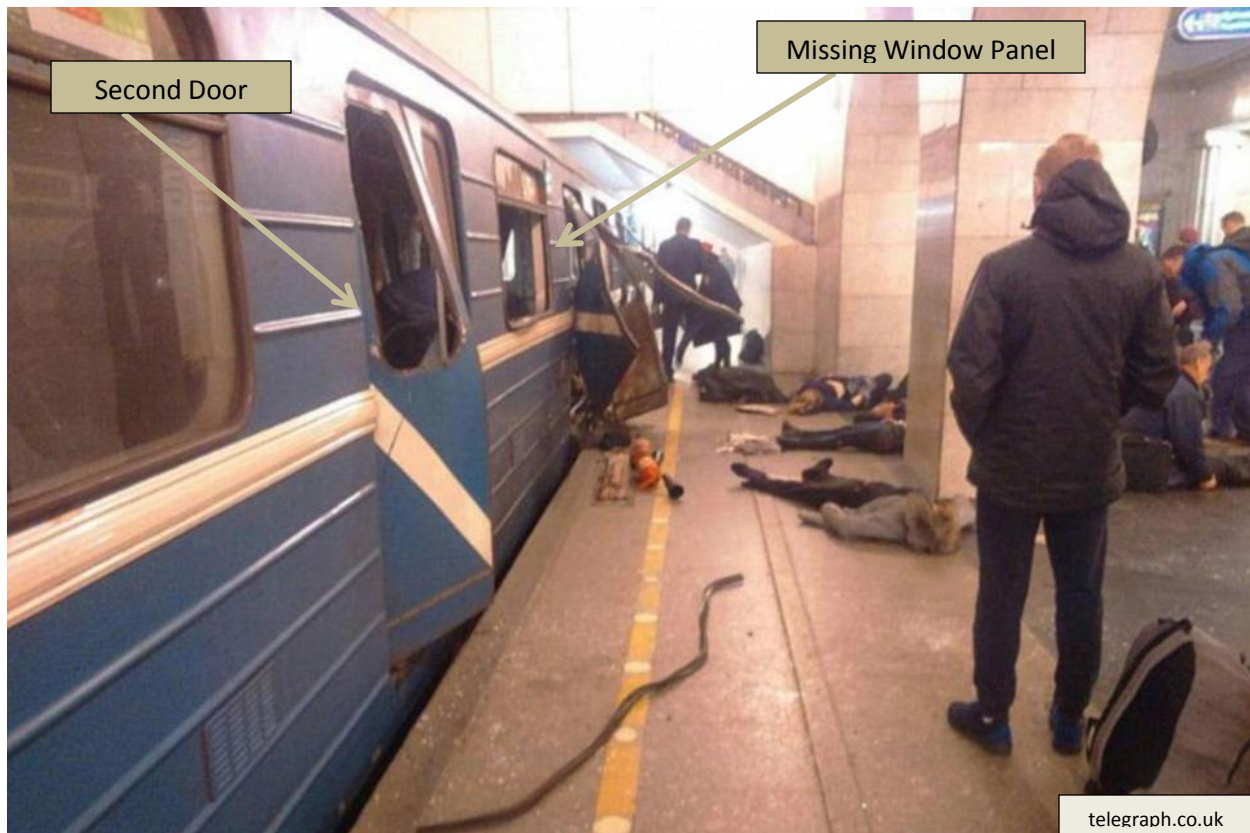
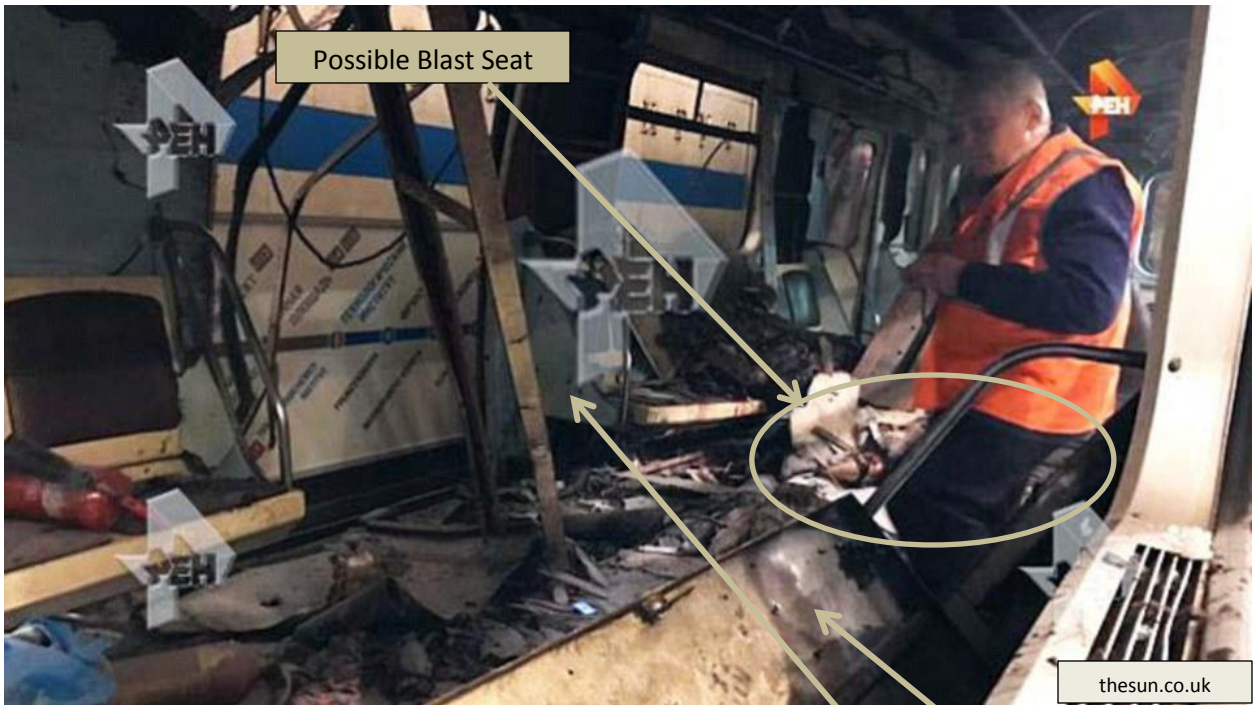
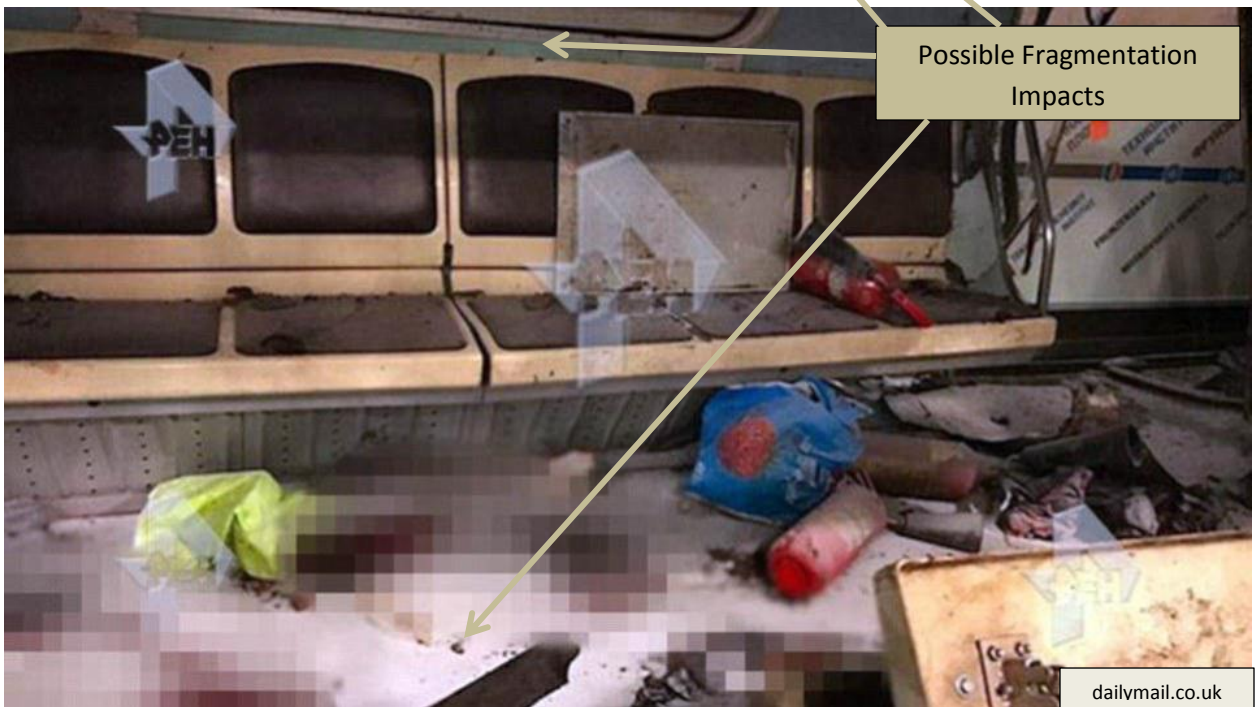
**2. Below are photos of the metro car's interior. There are indicators of additional fragmentation which is consistent with reports of "nuts and bolts" being added to the device. The blast seat can be surmised as being located slightly further back in the first picture than where the man in the orange vest is standing based on damage to the seating and interior. Russian officials estimate the explosive charge to be approximately 200g of TNT equivalent. This is not believed to be a suicide attack but rather the device was left on the train. The greater damage to the lower portions of the train indicate it was probably at or below seat height.**

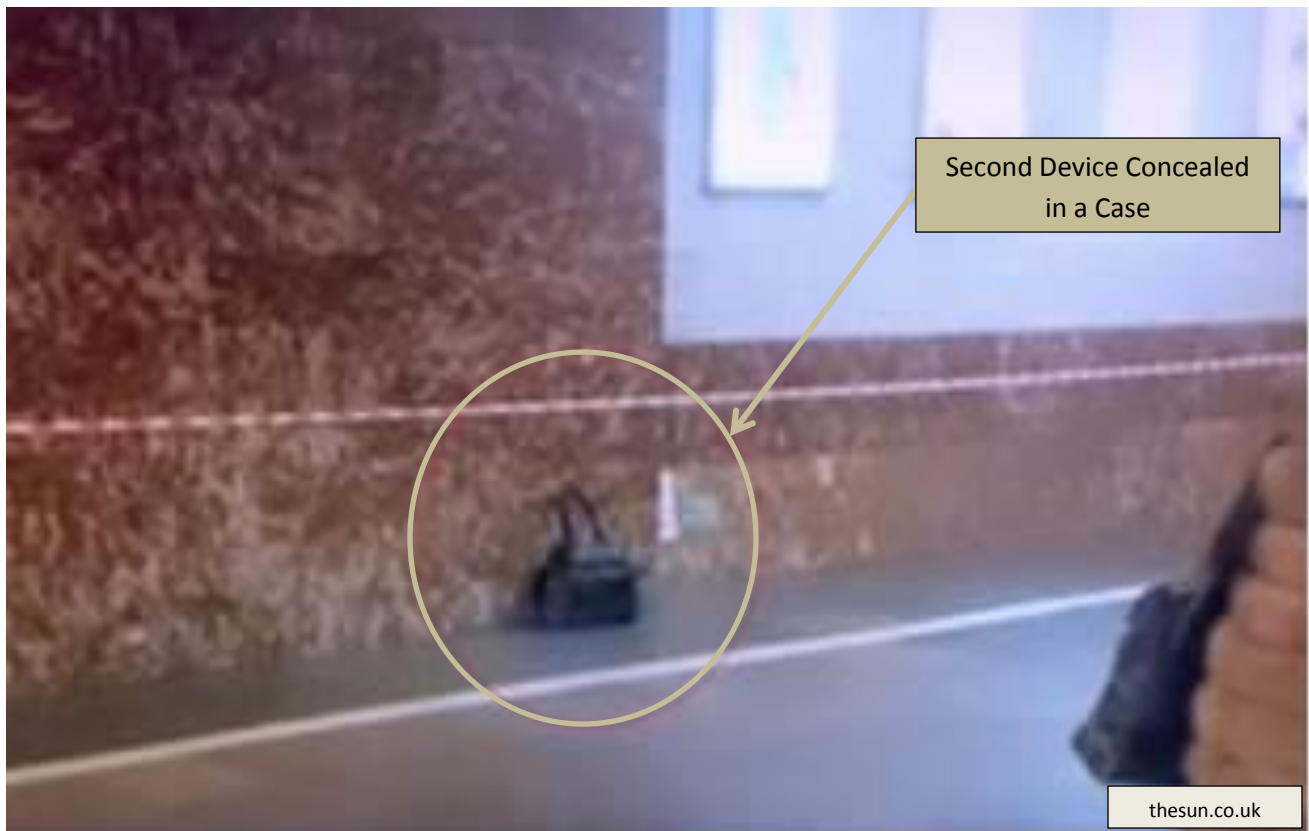
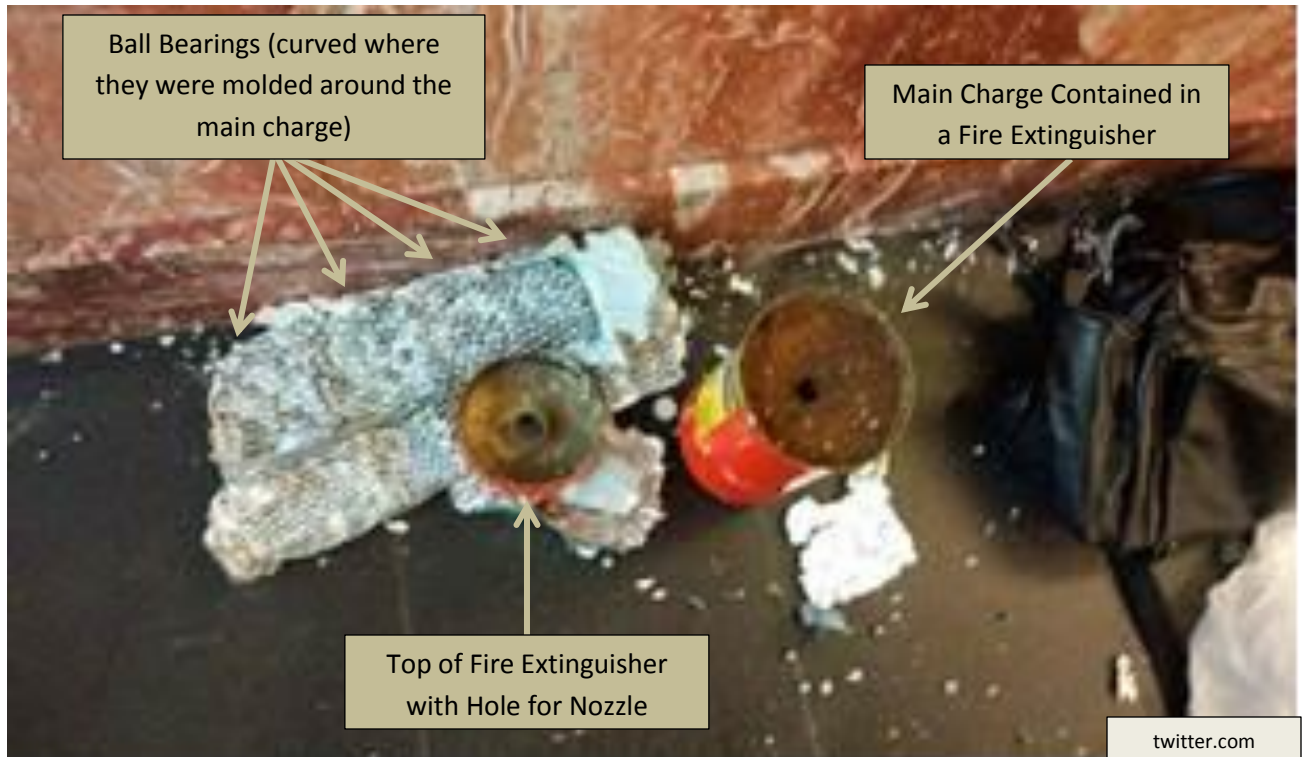
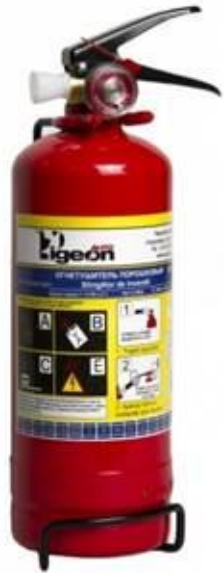
**3. Below are images of the second device at Ploshad Vosstaniya Station found by Police and rendered safe. It first appears concealed in a laptop or brief case. The second photo shows the main charge and**

**added ball bearing fragmentation. The charge container is a fire extinguisher, close to or the same as the Pigeon Auto (1kg) fire extinguisher in the third picture. This is also consistent with the Russian officials' approximation of 1kg explosive weight. The curvature of the ball bearings indicates they were wrapped around the exterior of the container. No initiation system is shown in the photos. The hole on the top of the charge correlates to the hole in the top of the fire extinguisher where the nozzle would be attached. This is possibly the place where a booster or initiation system would have been inserted.**
